Cleaning and Cleanliness Measurement of Additive Manufactured Parts

July 18th, 2017

*EM22 – Material Test, Chemistry &
Contamination Control Branch*

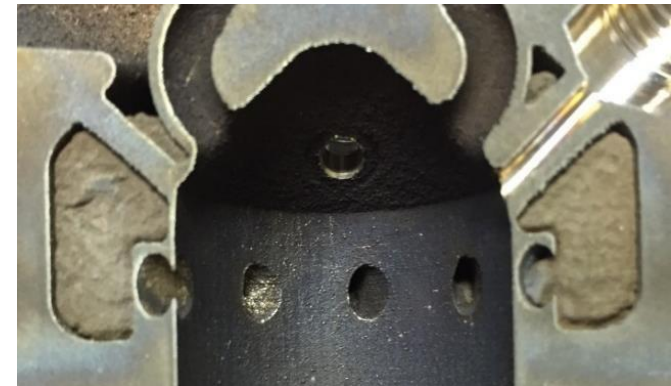
Remnant Powder Permanently Trapped in Interior Cavities following Inadequate Cleaning & Post Thermal Processing

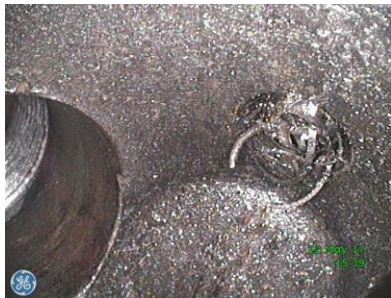
Burrs Trapped in Machined Hole

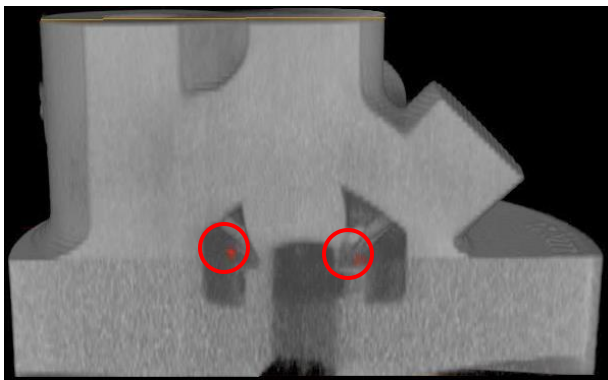
Front

#	Work Order	ASI #	Slice Height	# of Incidents	Observation of Powder
1	2017-V-0393	#1 - As Received	127 - 132	1	Chamber Side Wall, opposite Inlet 1 (40°)
2	2017-V-0413	#1 - Doped	136	1	Chamber Internal Side Wall, below Inlet 2 (90°)
3			127 - 132	1	Chamber Side Wall, opposite Inlet 1 (40°)
4			125	3	Chamber Internal Side Wall (45°, 135° & 260°)
5			118	2	Chamber Bottom (45° & 135°)
6			2017-V-0441	#1 - Cleaned	
7	2017-V-0398	#2 - As Received	118	2	Chamber, Interior & Exterior Wall (90° & 125°)
8	2017-V-0448	#2 - Cleaned	118	1	Chamber, Interior Wall (90°)
9	2017-V-0402	#3 - As Received	130 - 131	1	Chamber Side Wall, opposite Inlet 1 (10°)
10	2017-V-0453	#3 - Cleaned			
11	2017-V-0403	#4 - As Received / Doped	117 - 119	2	Chamber Bottom (100° & 180°)
12		#4 - Cleaned

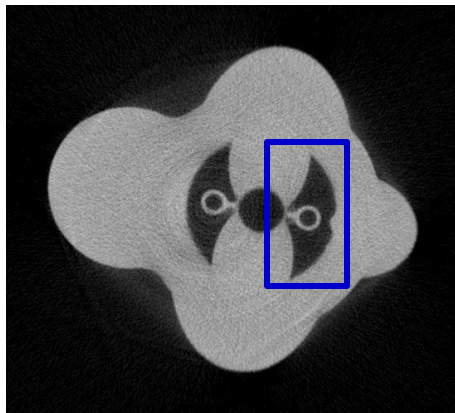
Powder deposition occurred in different areas as compared to the accrual locations of “As Received” test articles. As a result, the doping process does not appear to represent actual AM powder entrapment mechanisms. It may, however, represent powder dispersal during handling prior to post production processing.

Trapped Powder
Observed @
Elevation 136

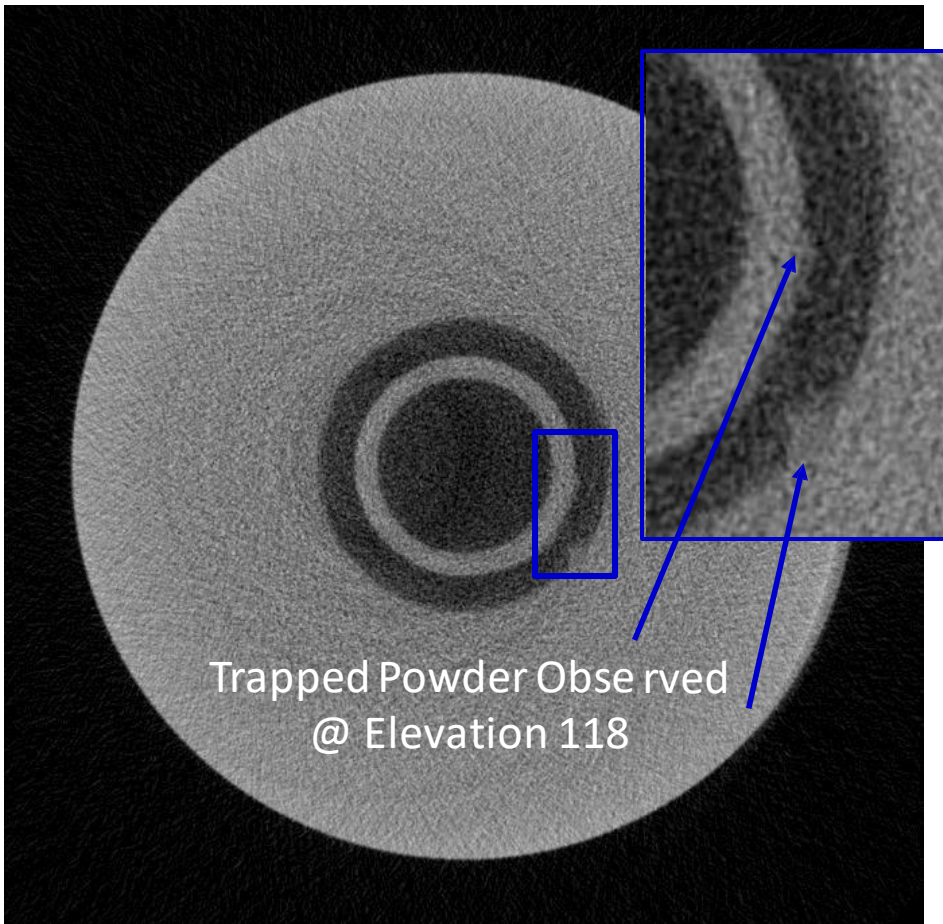
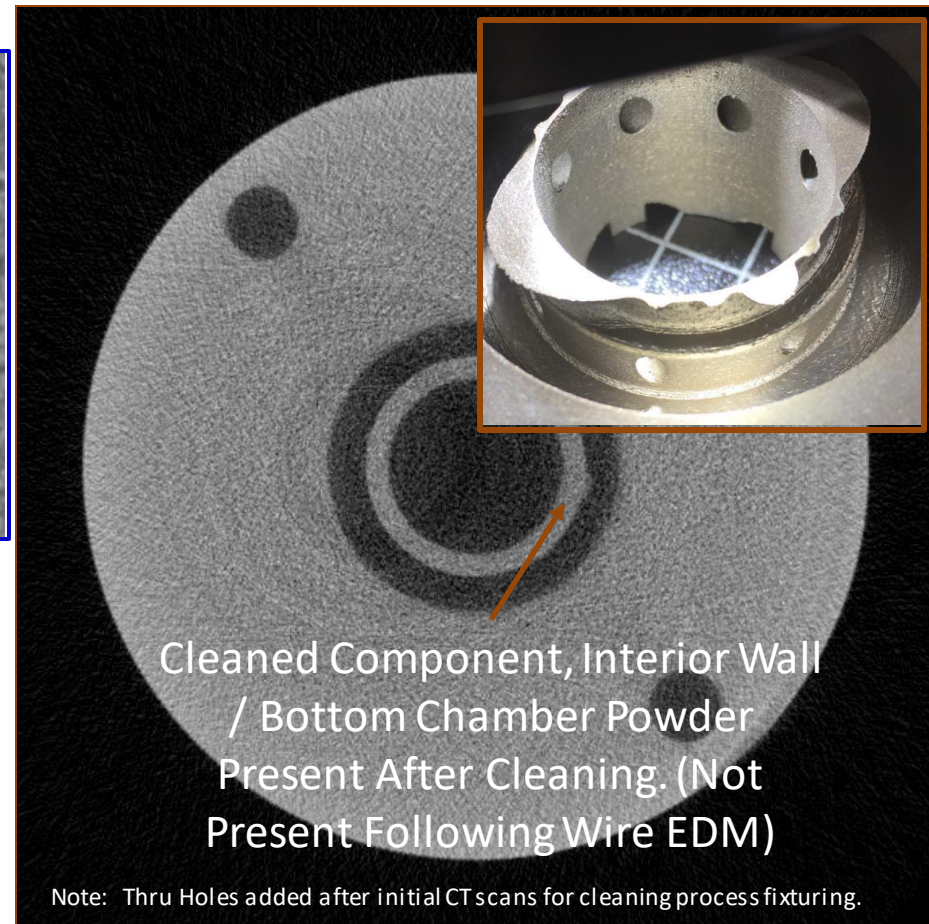
Component # 2 Analysis – As Received VS. Cleaned

Powder was observed in two locations. Cleaning removed powder at one location but not at the interior wall / bottom chamber surface. A wire EDM cut of the affected zone did not show the presence of any mechanical defect, thereby indicating that the artifact in question was most likely powder.

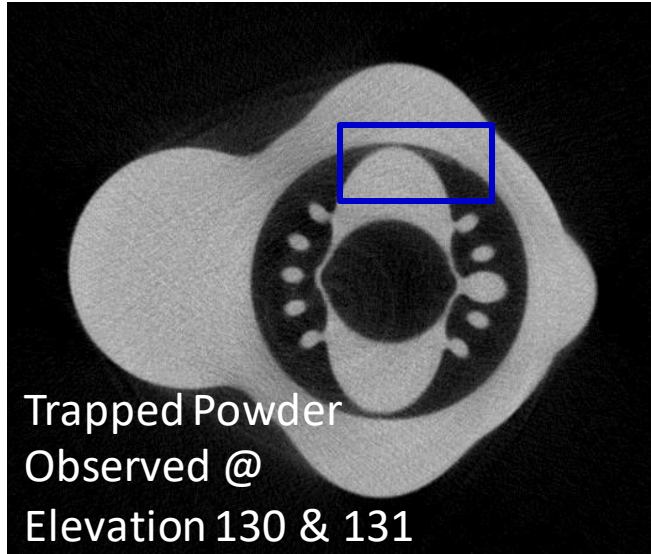
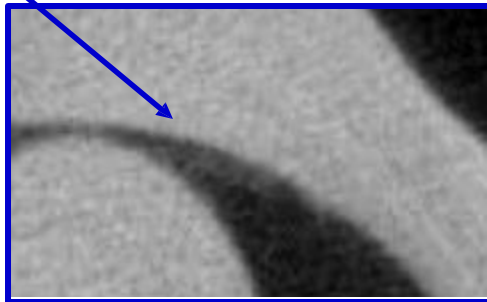
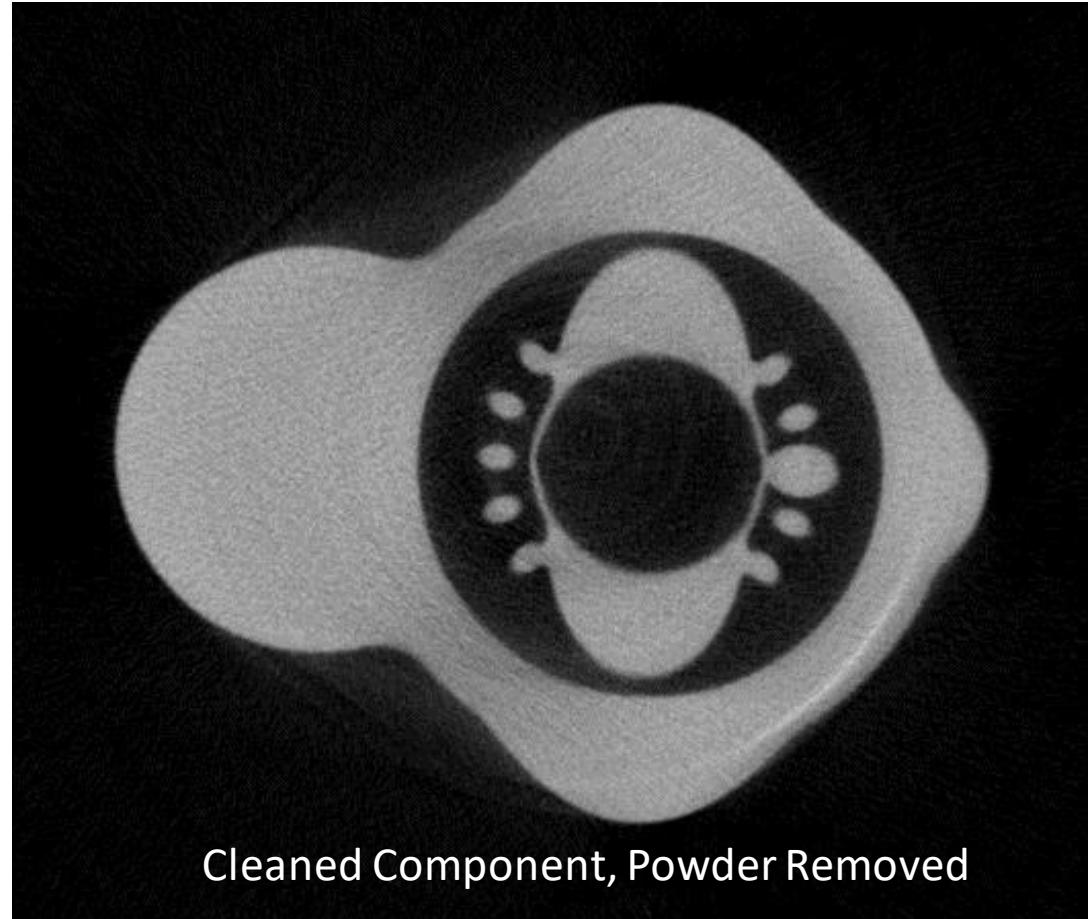
Component # 3 Analysis – As Received VS. Cleaned

Powder observed at the main cavity side wall on the upper corner.
Following cleaning, the powder is absent.

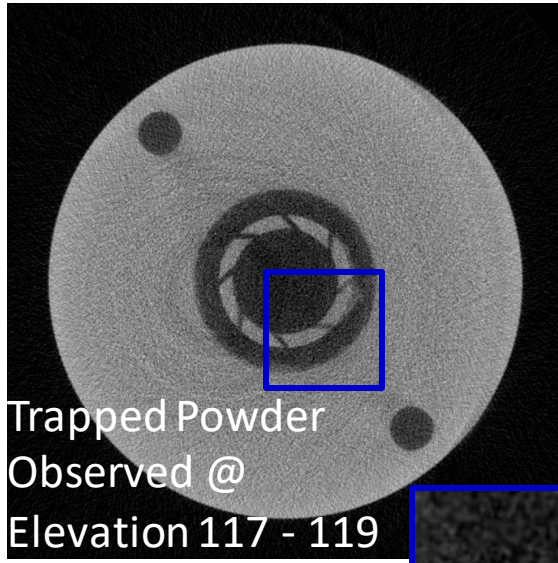
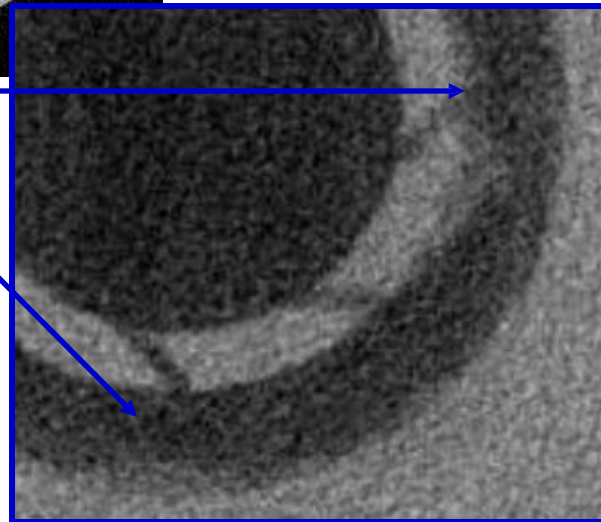
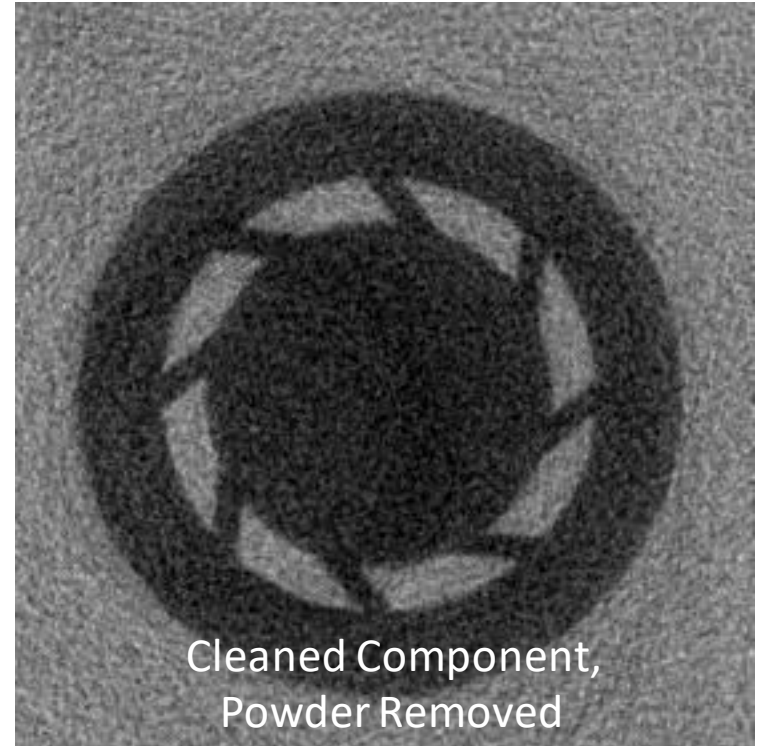
Component # 4 Analysis – As Received / Doped VS. Cleaned

Powder observed at the bottom main cavity in two locations, cavity angled outlet and at the exterior wall. Remnant powder is absent following cleaning.
