***Effect of Concurrent UV Irradiation
and Contamination on Silver Coated
Teflon Radiator Surface***

***De-Ling Liu, Jesse D. Fowler, Hyun Kim,
Diana Alaan, Aura Labatete-Goeppinger,
Robert Moision***

***July 19, 2017
NASA Contamination Workshop***

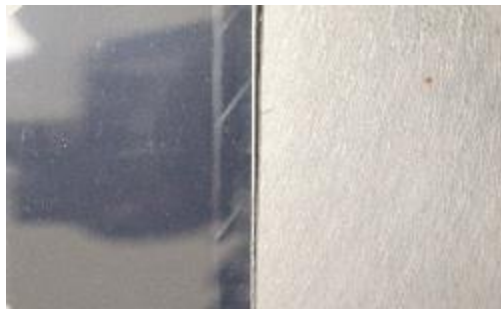
smooth SCT abraded SCT

Surface roughness plays a role in contaminant deposition

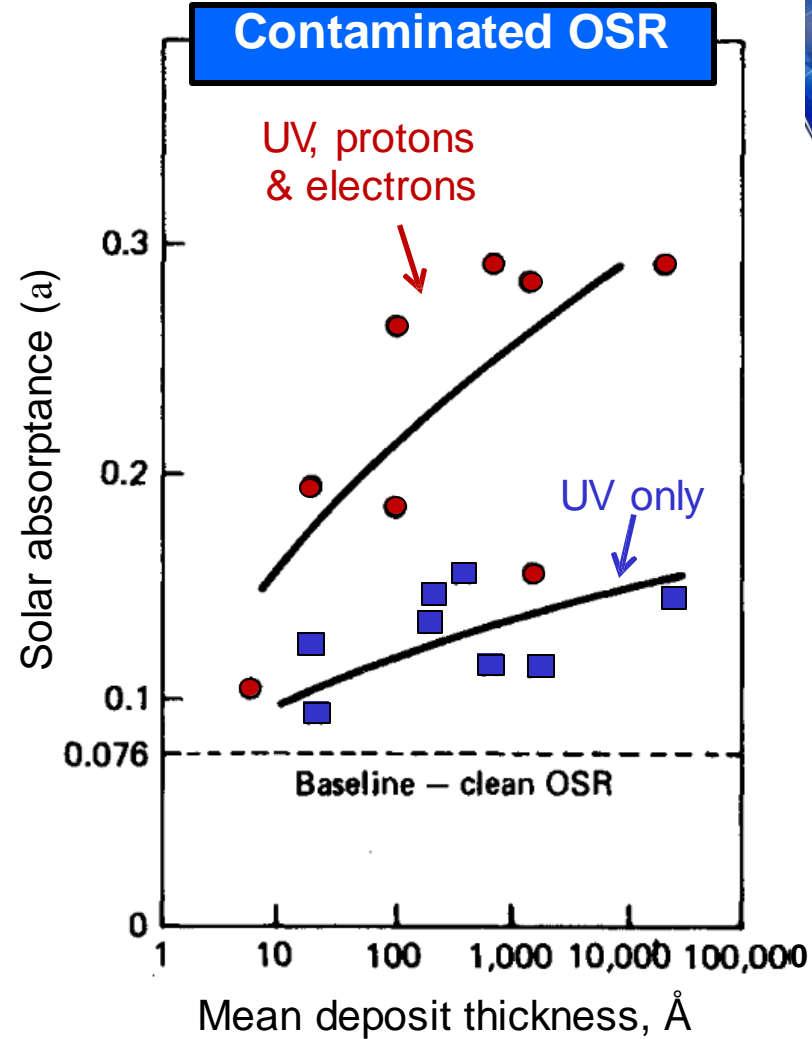
J.A. Neff, C.R. Mullen, L.B. Fogdall, J. Spacecraft & Rockets, **23**: 386-390, 1986.

**Space radiation exacerbates the degradation effects of contaminant films;
More degradation on rough surface (with AR coating) than smooth surface**

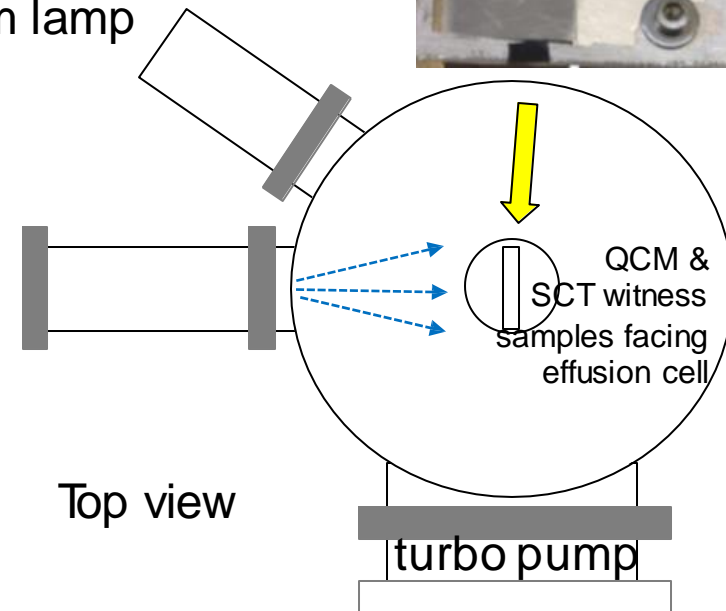
Characterize pre- and post-alpha values for thermal degradation assessment

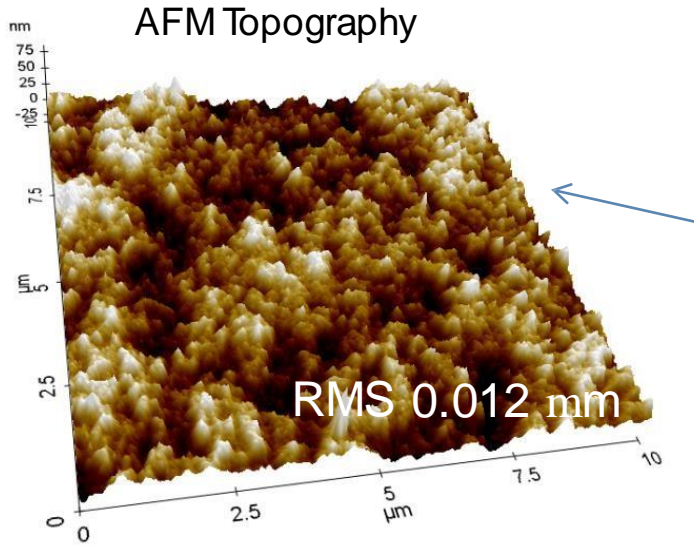
smooth SCT abraded SCT

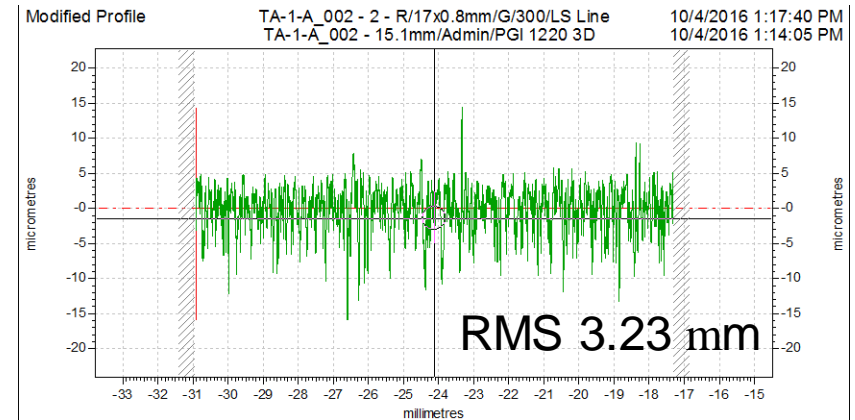
Surface Profilometry

Abraded SCT roughness is 100X more than smooth SCT

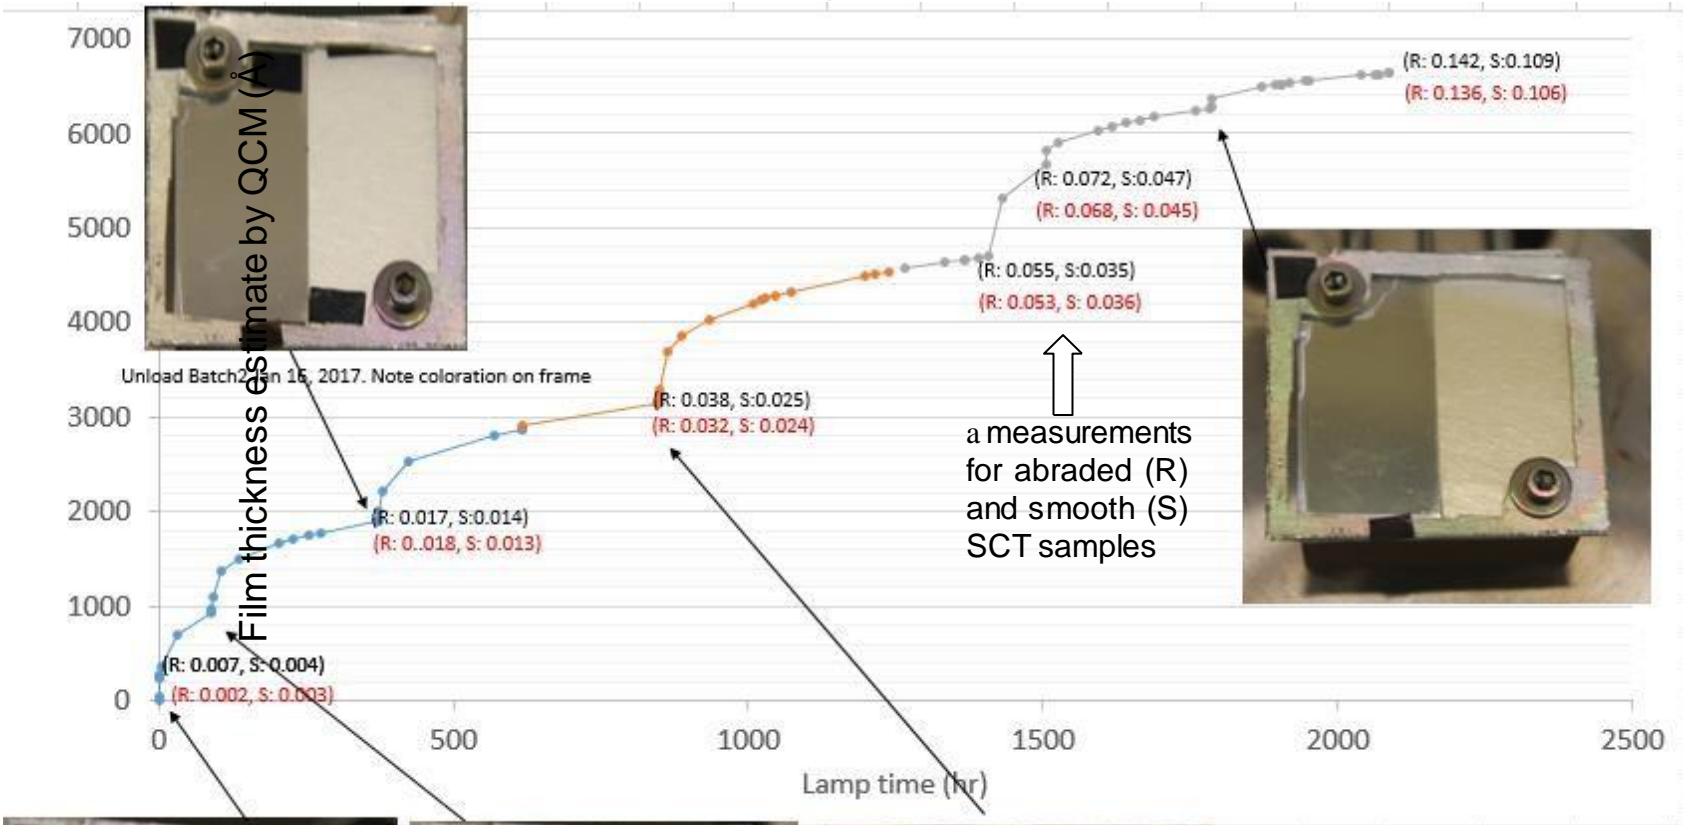
Real-time accumulation monitoring provided by in-situ QCM data

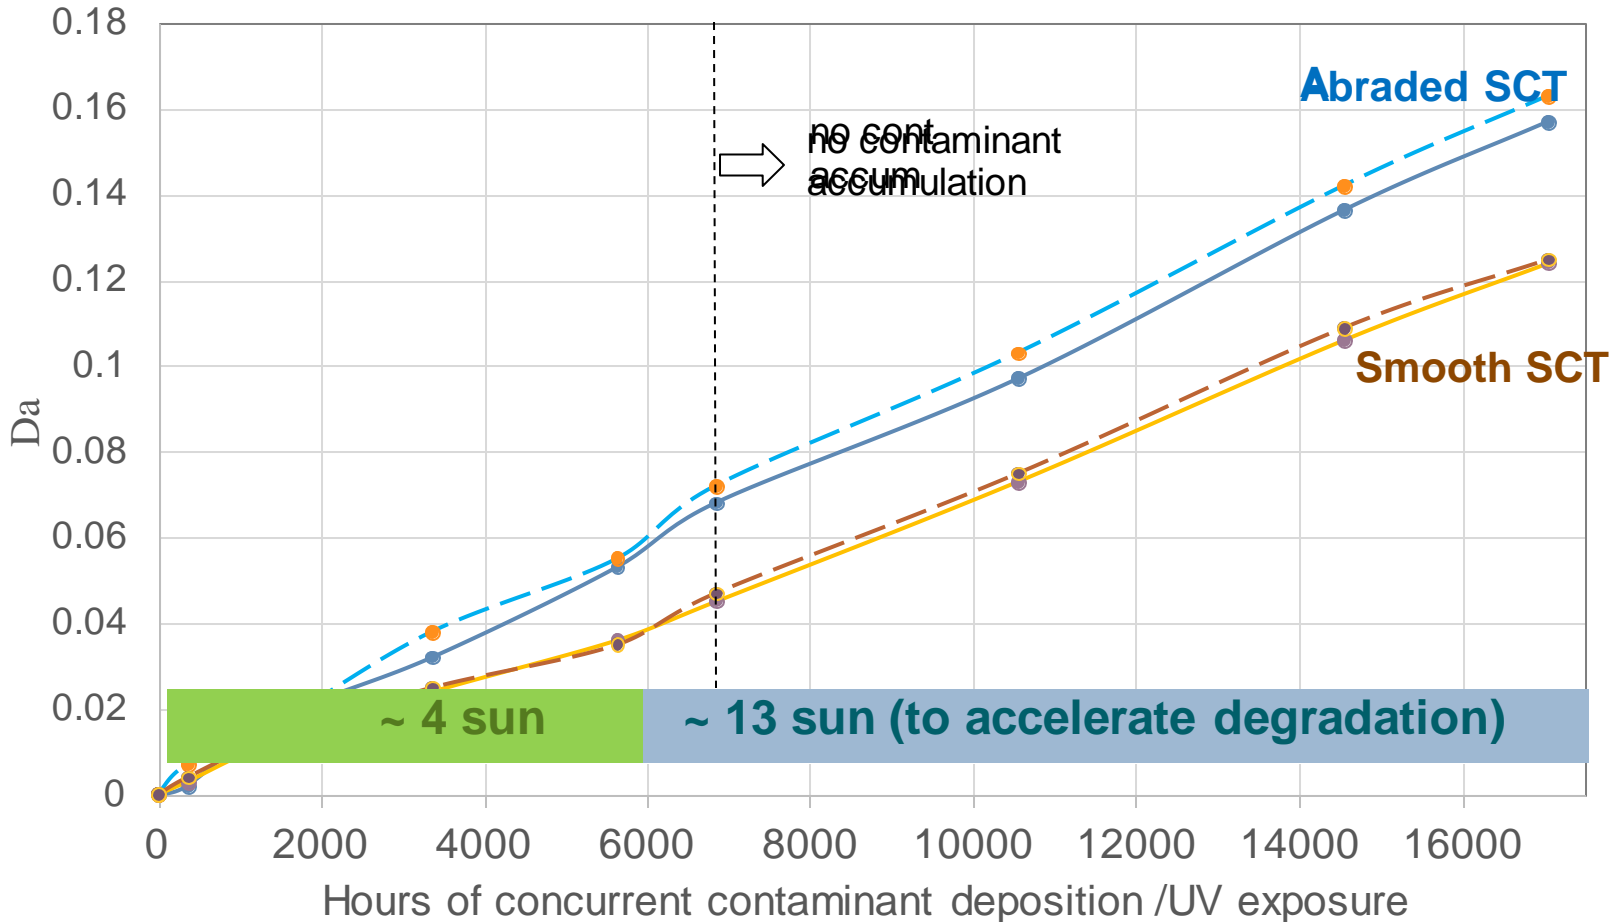
Abraded SCT shows more degradation than smooth SCT

* The alpha measurements are based on two methods calibrated via VDA (vapor deposition aluminum) in solid lines and IS (integrating sphere) in dash lines

Distinct difference in D_a between smooth vs. abraded SCT

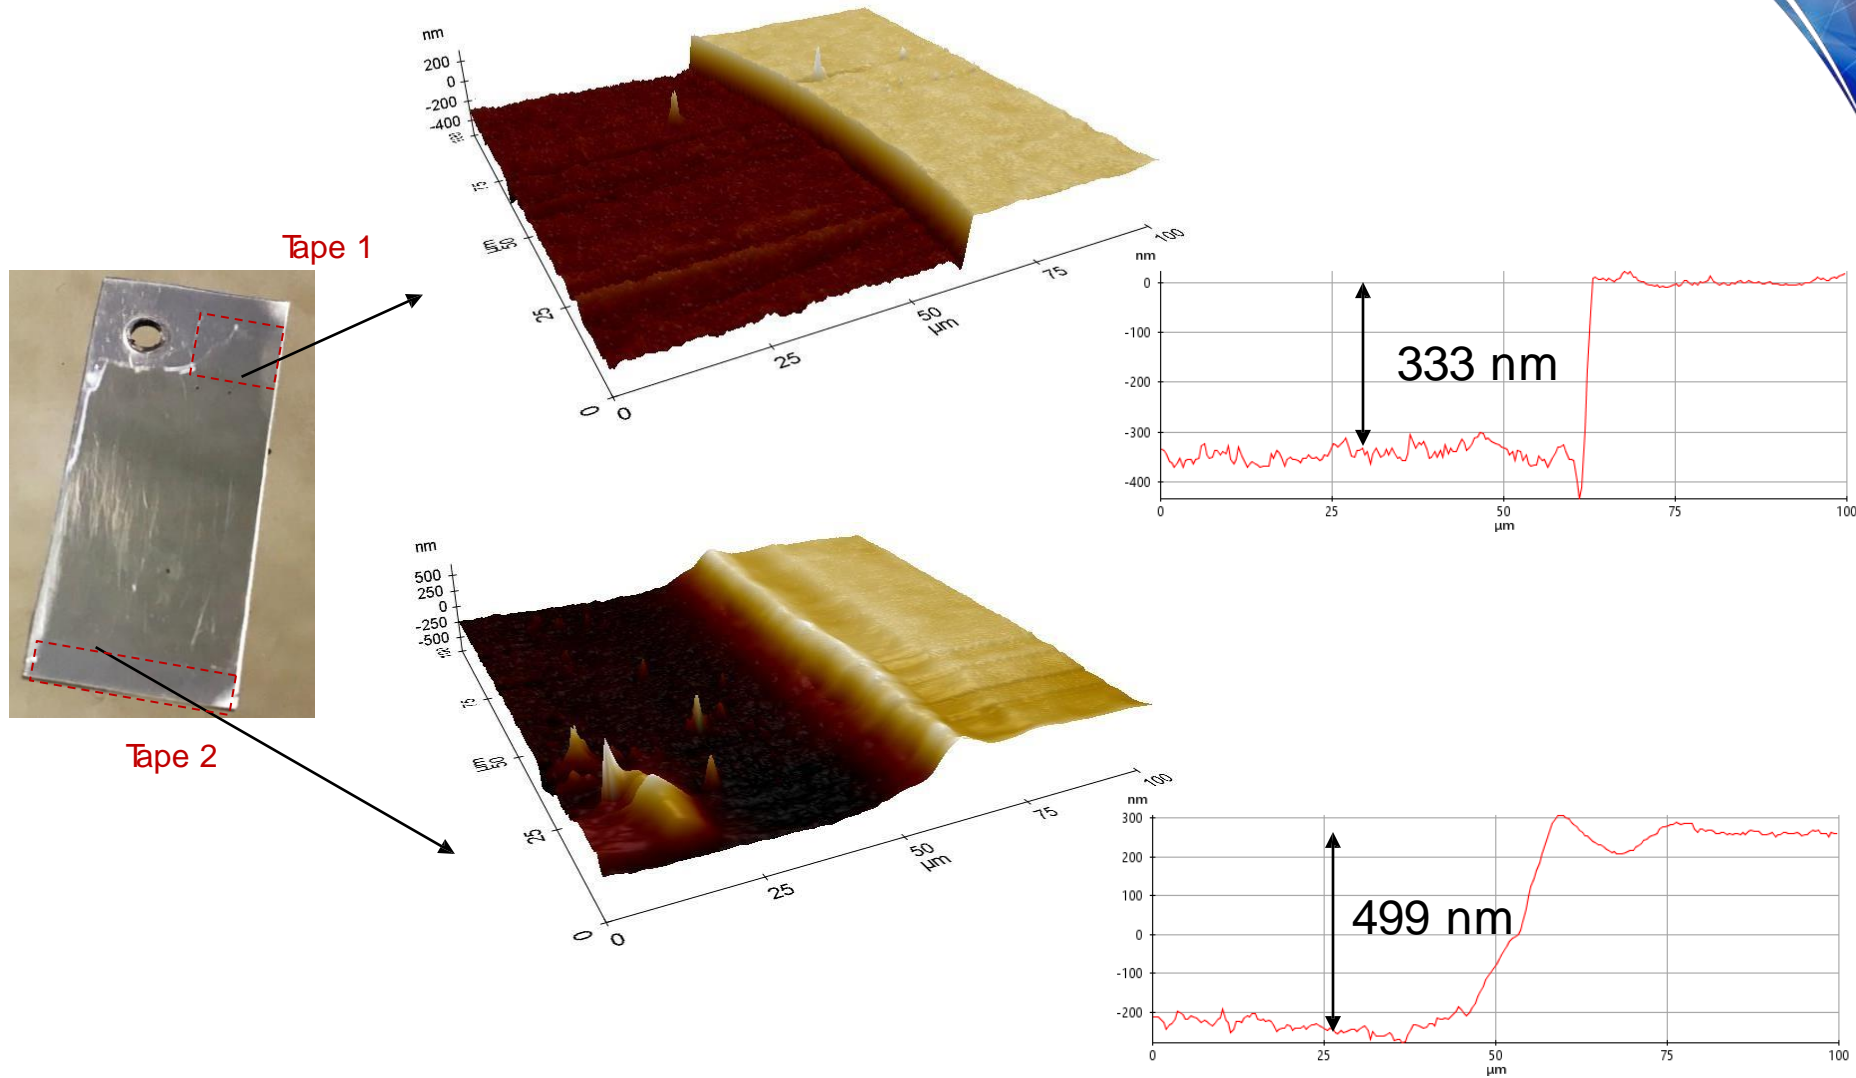
Film thickness estimated by comparing exposed vs. unexposed area (masking tape)

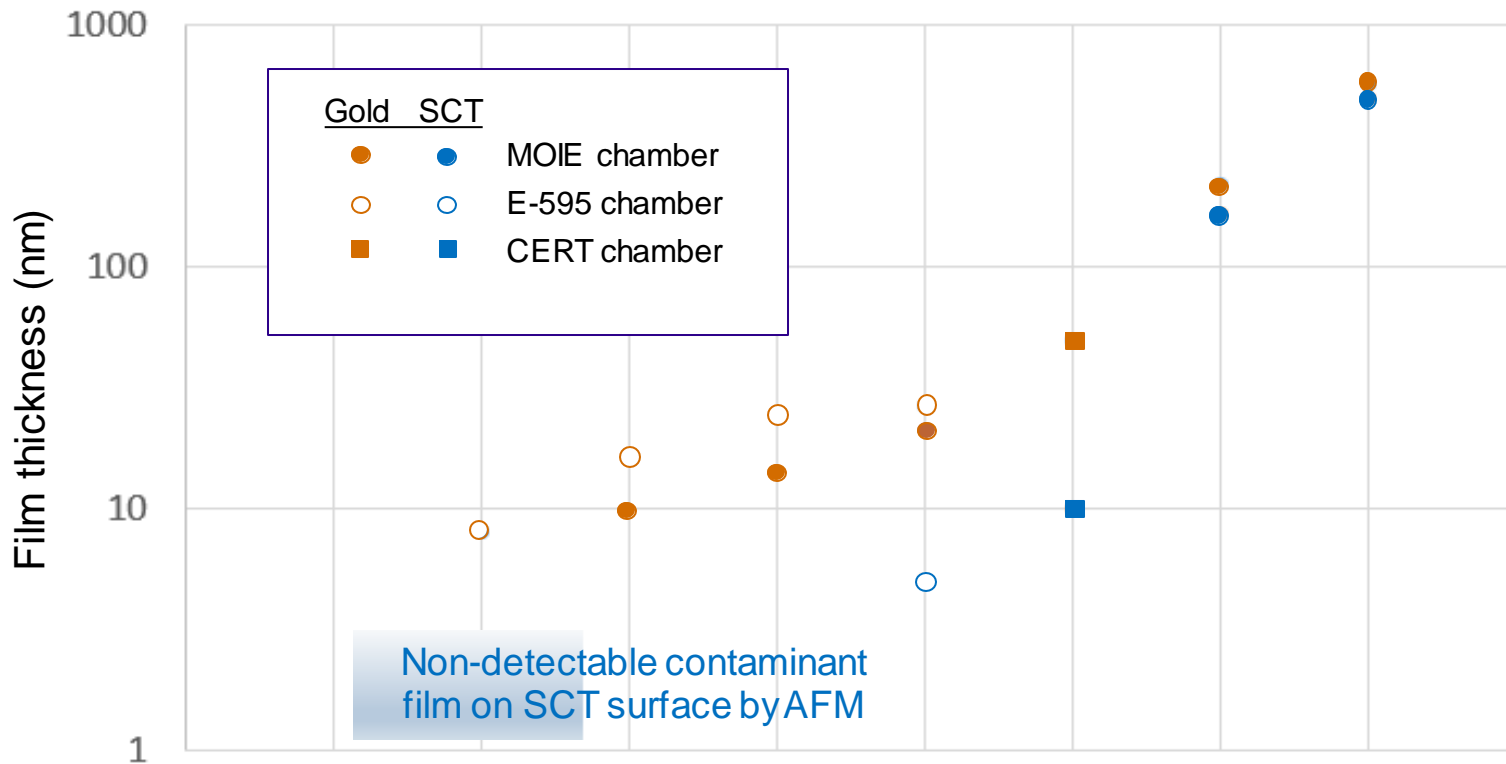
- Significant slower contaminant accumulation rate on SCT vs. gold surface in early deposition phase
- Film thickness appears to converge between gold and SCT after certain film thickness

Observed different contaminants deposition rate on SCT and gold surfaces

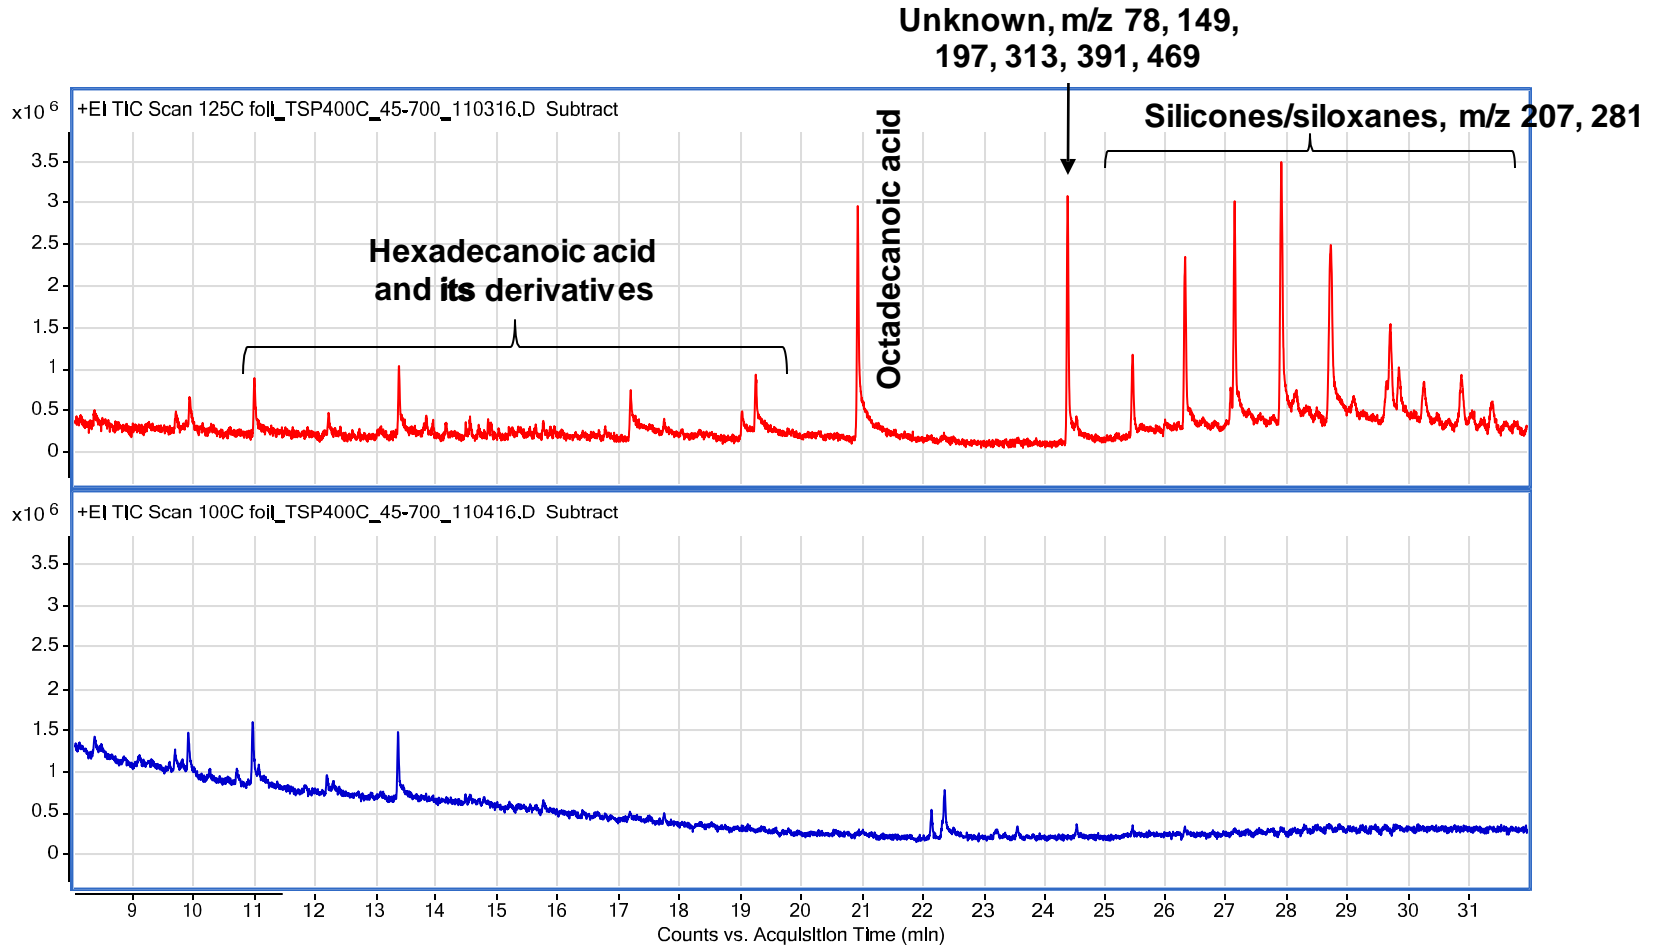
100°C and 125°C source temp

Different chemical species when SV materials outgassed at 100 and 125 C for 24 hours
