Contamination Analysis and Identification by Vibrational Spectroscopy

2017 NASA Contamination, Coatings, Materials, and Planetary Protection Workshop

Deformulation and Contamination Analysis via FTIR

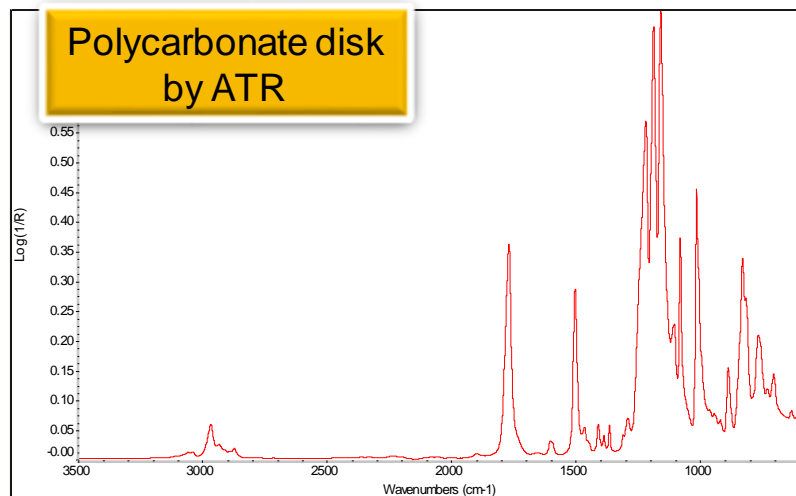
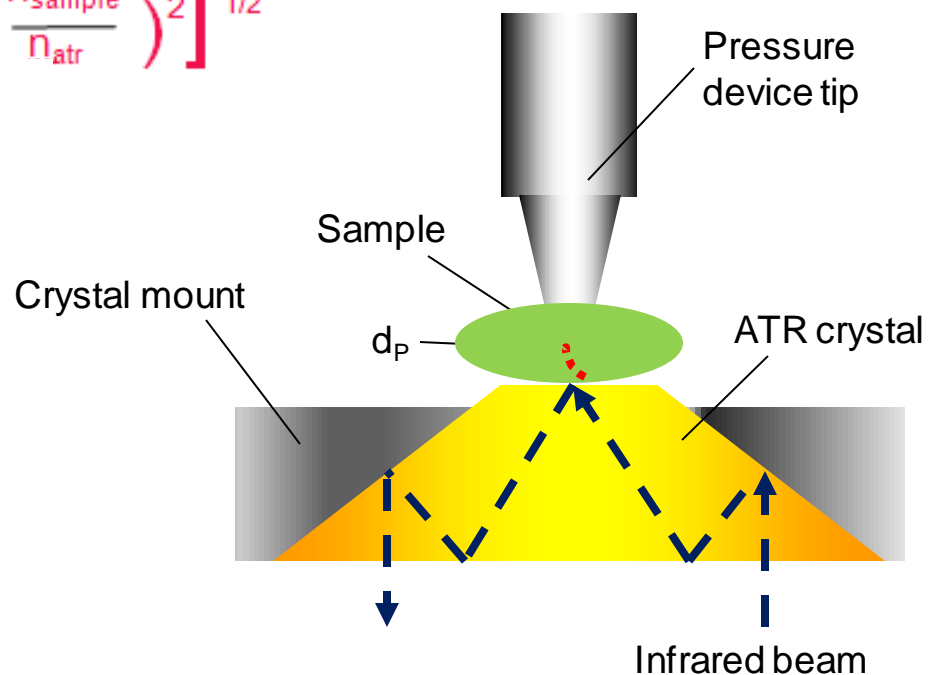
Basics: Depth of Penetration

- Attenuation occurs by sample absorption: $A = \epsilon lc$
- The Evanescent wave probes short distance (~1-2 micron)
 - Measures surface & near-surface only
 - Path Length 'l' characterized by depth of penetration

$$d_p = \frac{\lambda}{2\pi n_{\text{atr}} \left[(\sin^2 \theta) - \left(\frac{n_{\text{sample}}}{n_{\text{atr}}} \right)^2 \right]^{1/2}}$$

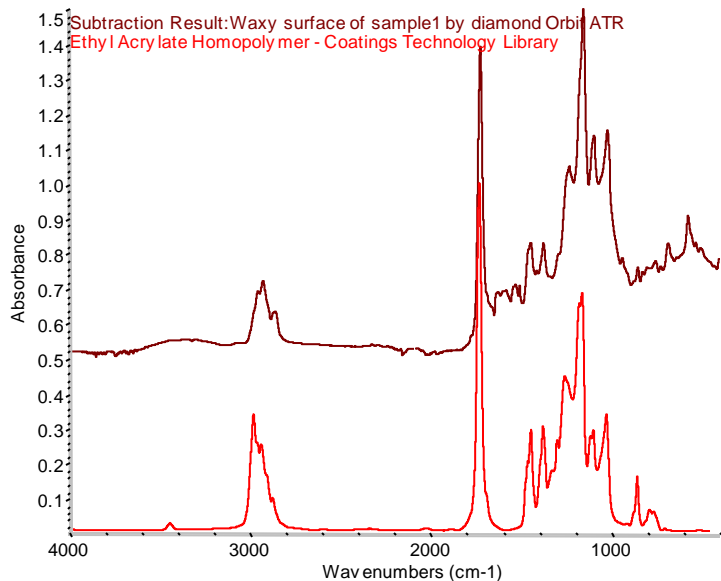
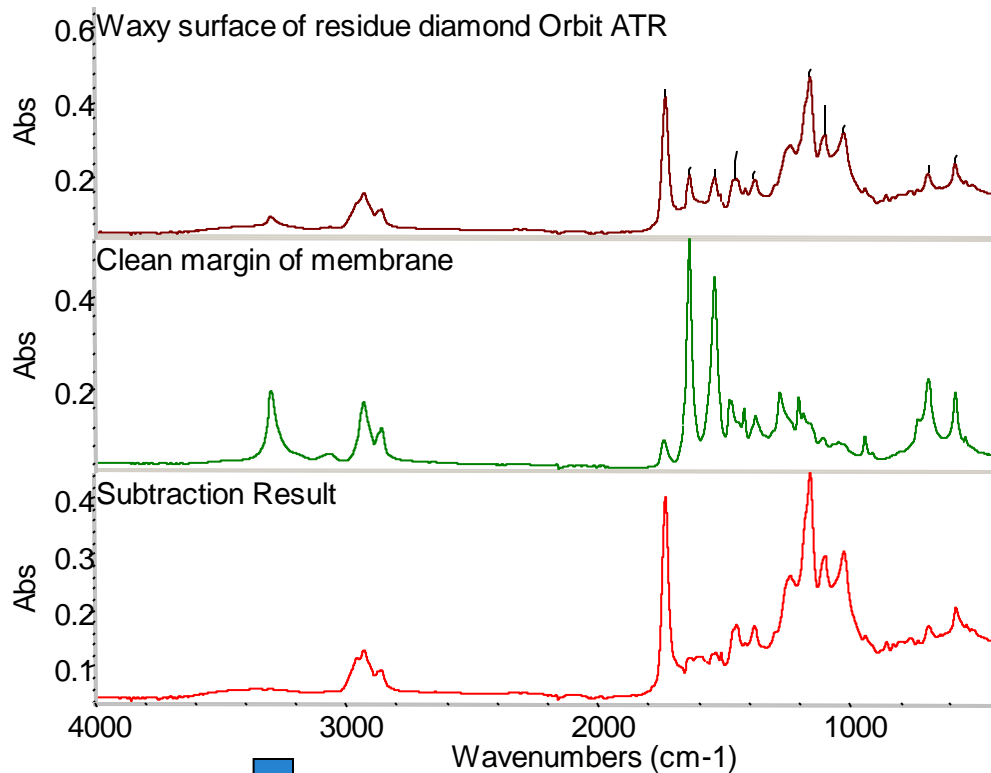
Failure Analysis via ATR

- Residue collected on filter membrane
- Analyzed by direct contact with Diamond ATR
 - Membrane + residue
 - Subtract membrane
 - Search

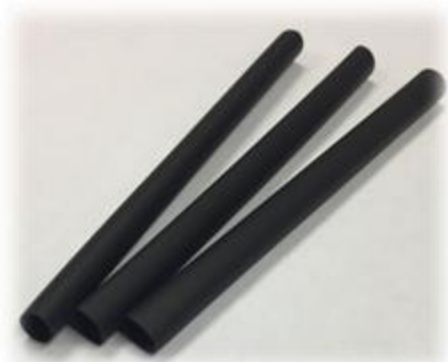
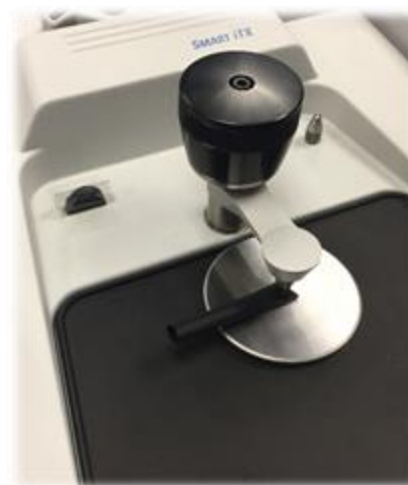
Heat Shrink Tubing

- Attempt to chemically identify and reverse engineer heat shrink tubing
 - Gardner Bender Polyolefin (HST-250)
- Since tubing appears to have a high loading of carbon black, analyze via germanium ATR as it has a lower depth of penetration

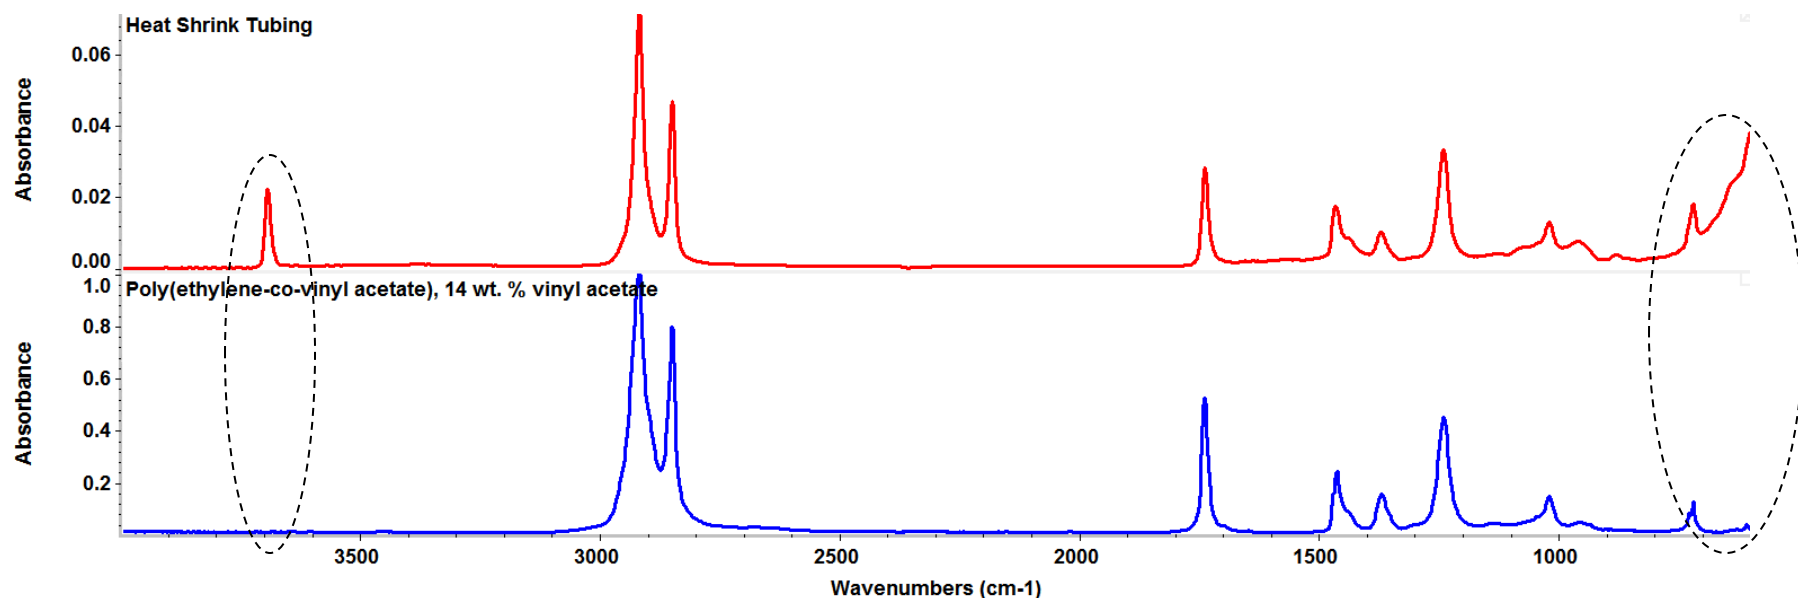
Initial Identification of Tubing

- Polyolefin tubing (red) library search result (blue) has strong match value
 - Polymer tubing C-H & C=O stretches appear to be highly correlated
- 3700 cm^{-1} stretch and low wavenumber region do not match well

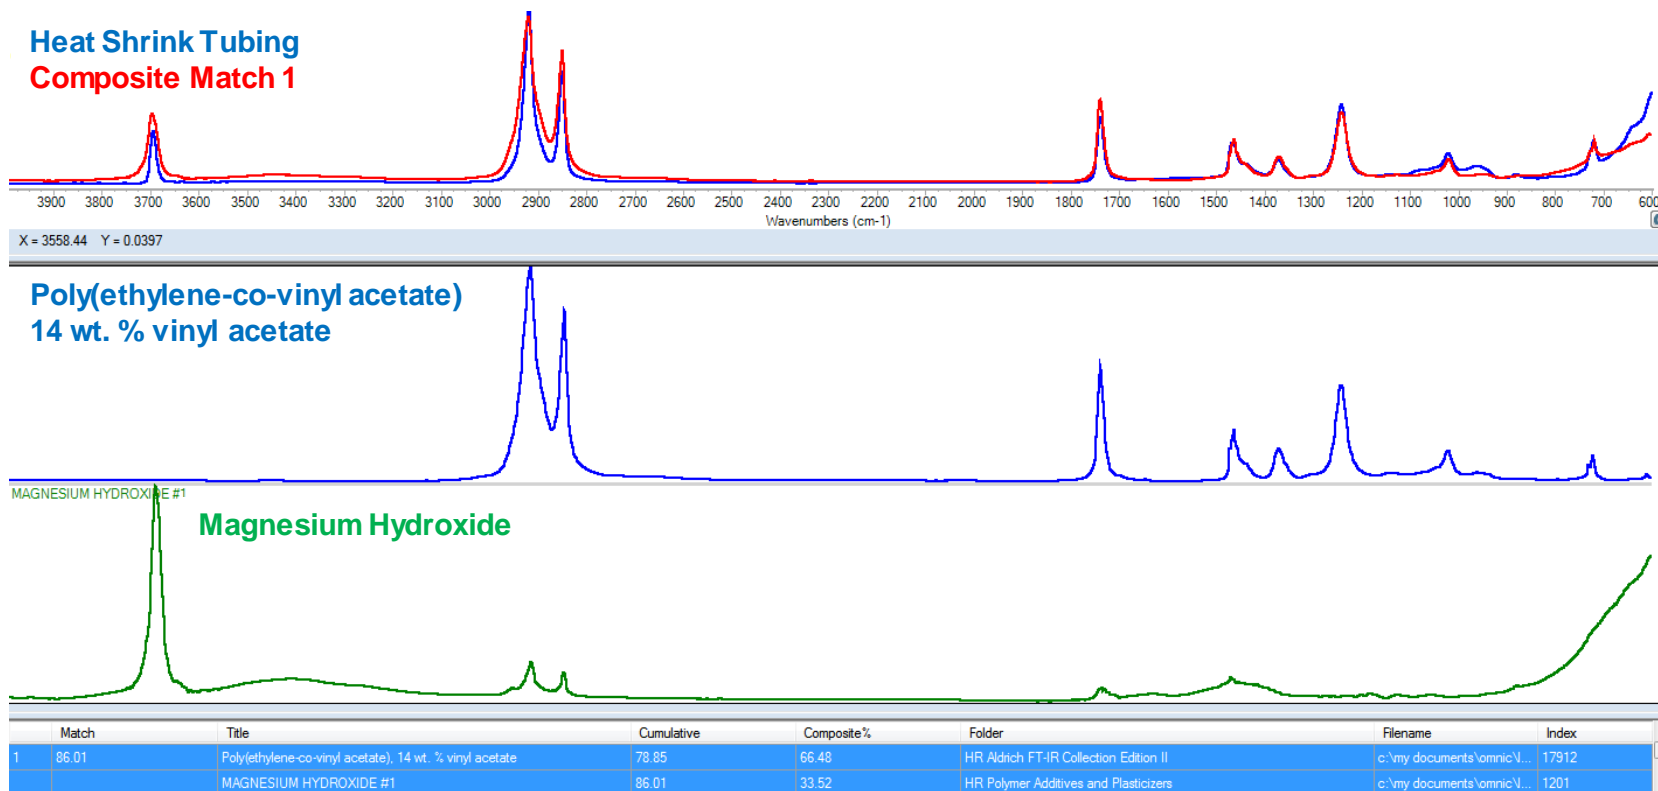
OMNIC Spectra Shows Multicomponent Match

- Peak at 3700 cm^{-1} and low wavenumber tail appears to be from an inorganic filler - magnesium hydroxide
- MgOH is used as a flame retardant

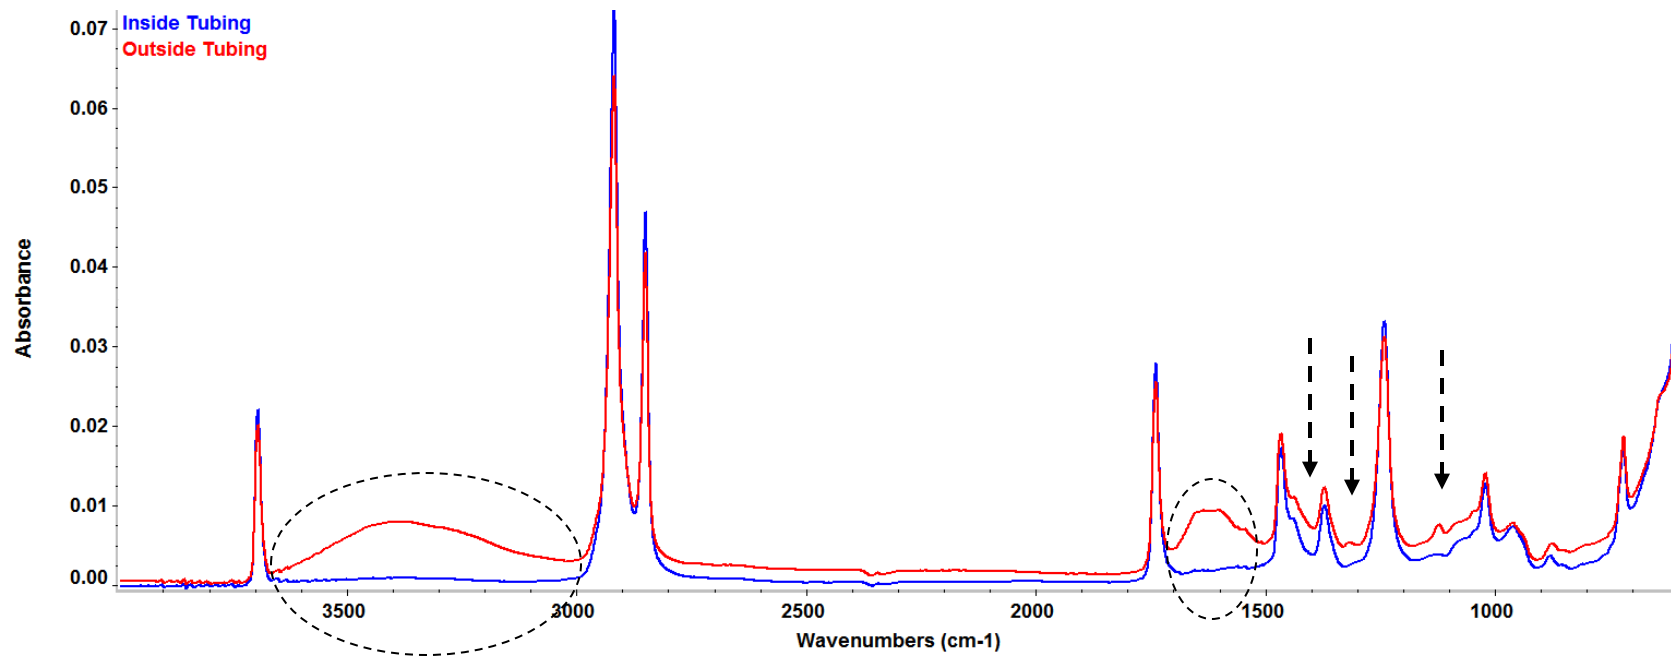
Outer Tubing

- Spectral changes from **inner tubing** is different from **outside** of the tubing
- Why would outside tubing have another chemical coating?
 - What is coating? And what is its purpose?

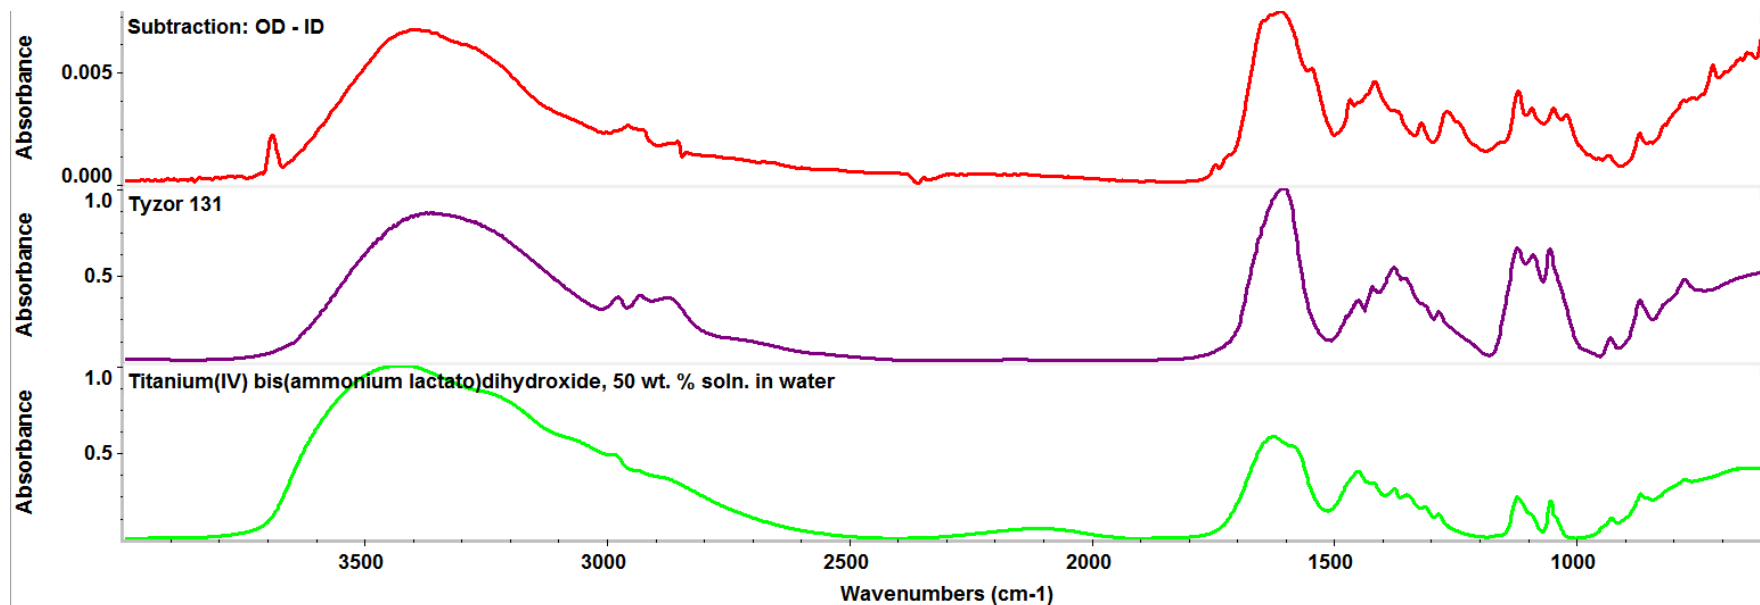
Identification of OD Coating

- Library search of outside coating shows match for Tyzor 131
 - Organic titanium complex made by DuPont as a cross-linking agent
- As polyolefin tube is heated – Tyzor 131 enhances crosslinking causing tube to shrink

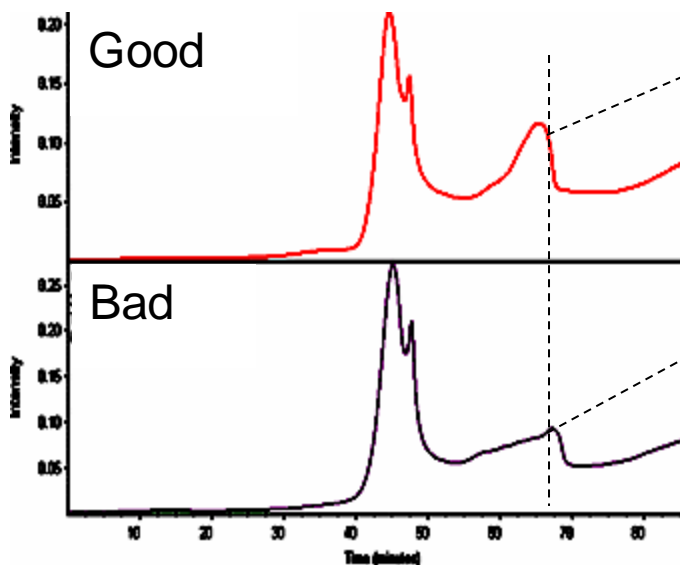
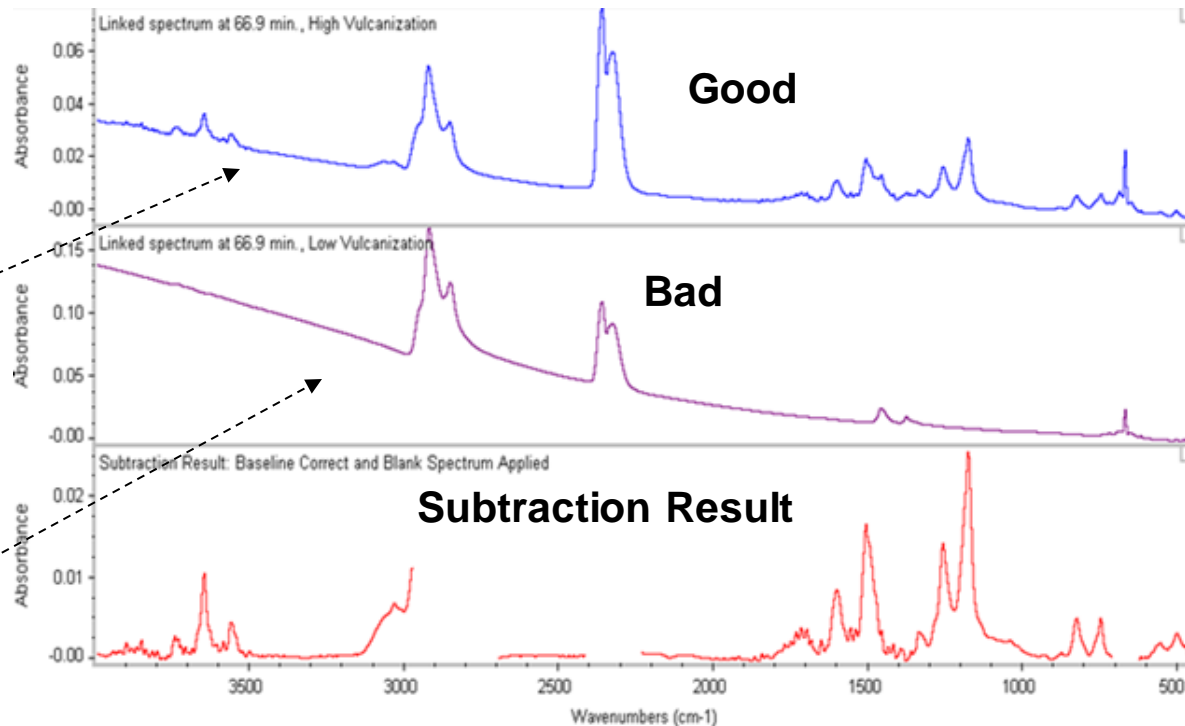
Gram-Schmidt Plot

- Deformulation and Failure Analysis
 - Rubber gaskets were found to be failing in the field
 - TGA analysis of failing gaskets shows incorrect formulation
 - Subtraction result shows chemical differences

IR of vapor at 67 min

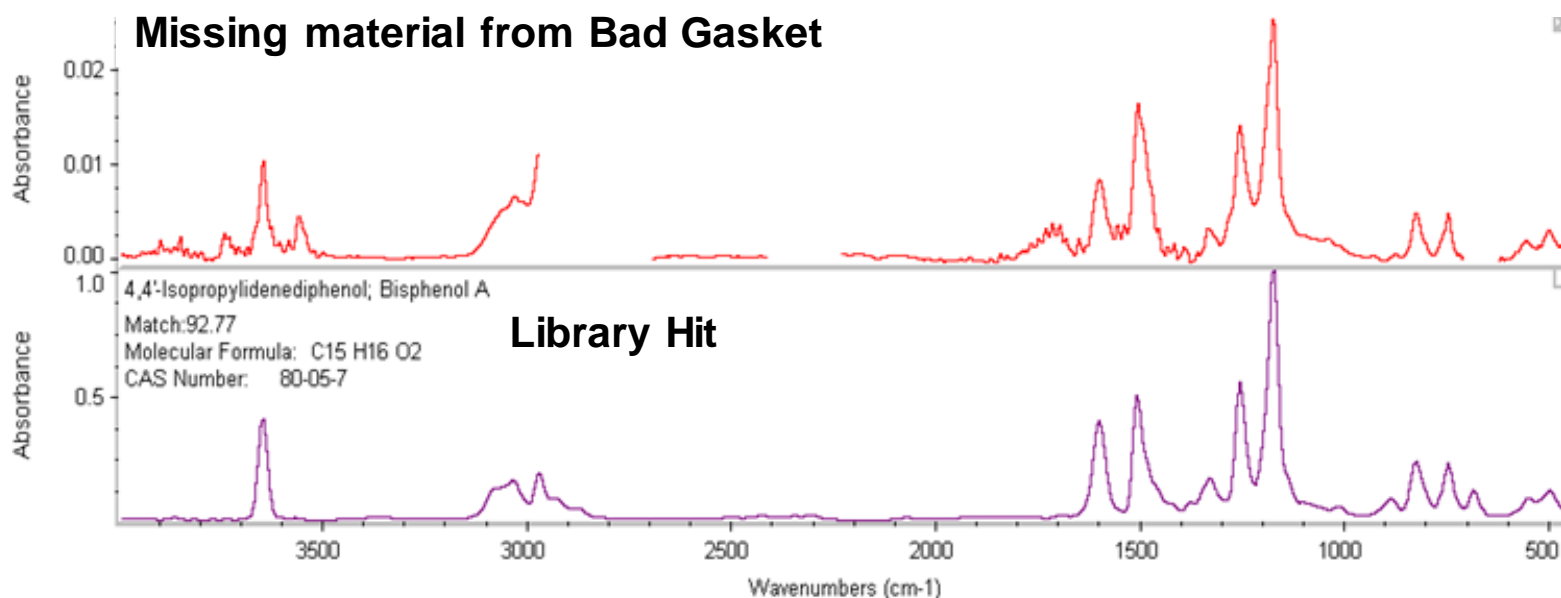
- Bad gasket does is missing bisphenol A
 - Chemical information to support early failure in field
- TGA coupled with IR allows for chemical evidence of failure
