Cleaning and Cleanliness Measurement of Additive Manufactured Parts

July 18th, 2017

*EM22 – Material Test, Chemistry &
Contamination Control Branch*

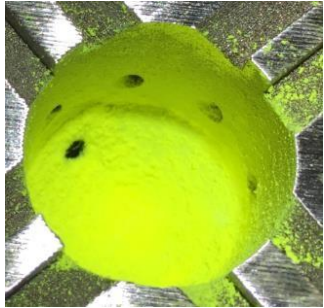
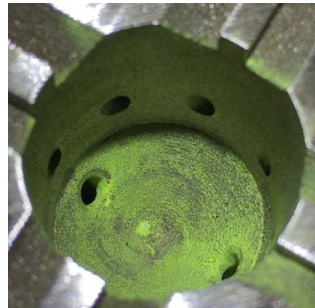
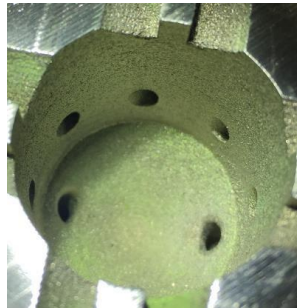
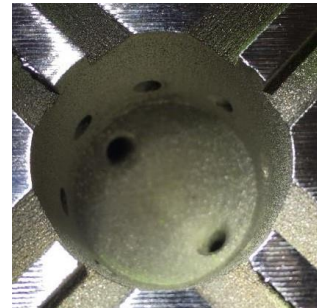
Pictures of various cleaning methods following fluorescent powder doping

Progression of cleanliness efficiency. (CO₂ Snow yielded the best results.)

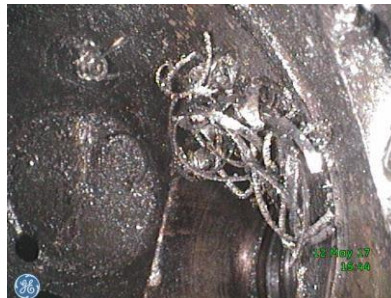
Gradual Removal of Burr

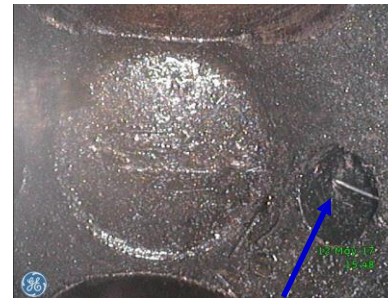
Burrs Removed (Wire in View)

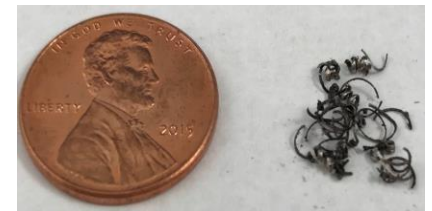
Relative Size of Burr

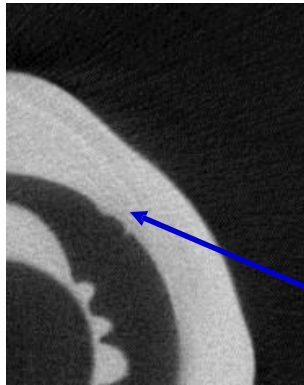
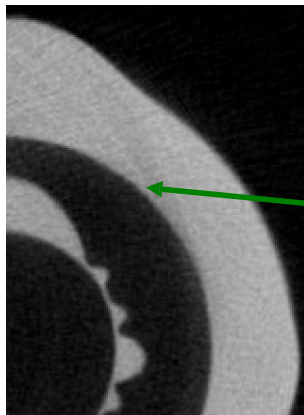
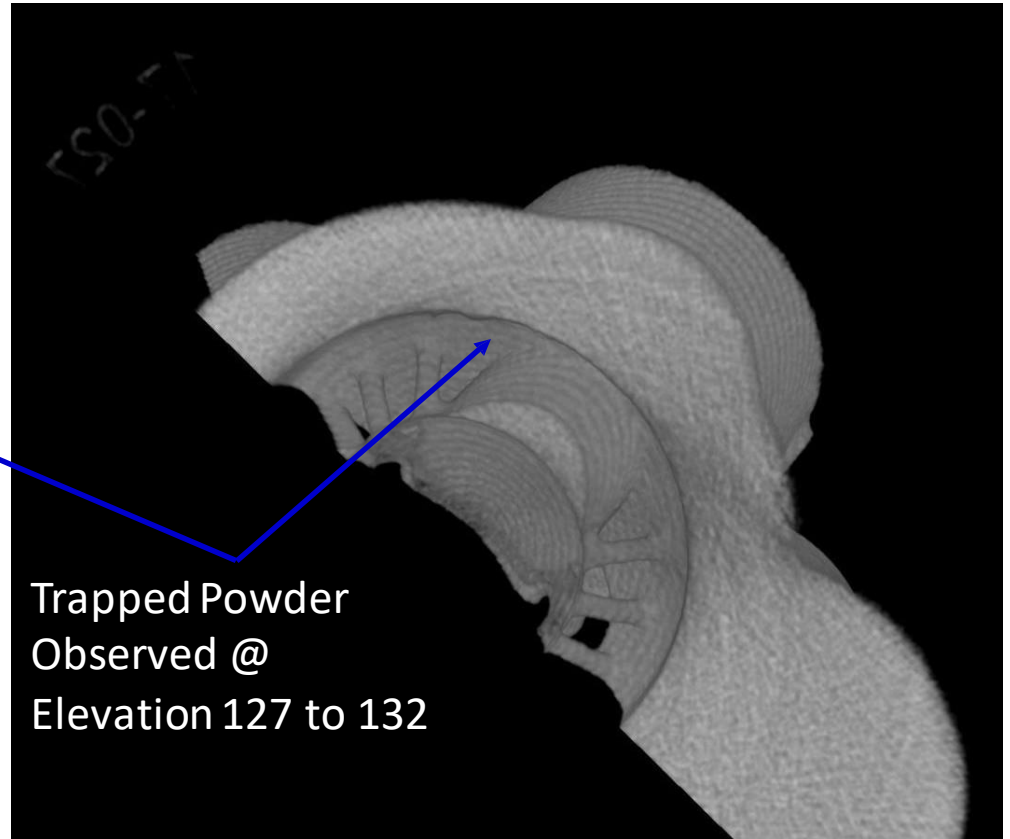
Component # 1 Analysis – As Received VS. Cleaned

A total of four components were manufactured and cleaned using the prototype method. This method effectively removed process and doped powder from 11 of the 12 excursions. Following CT analysis of the first component, where only one small patch of remnant powder was found, it was decided to dope half of the components for test capability.

Cleaned Component,
Powder Removed

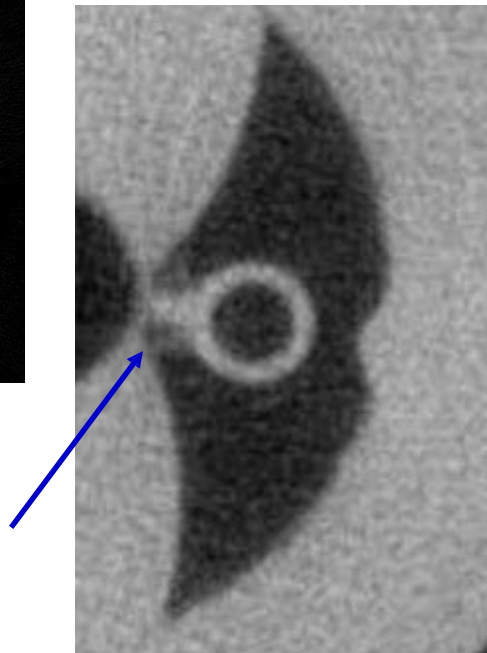
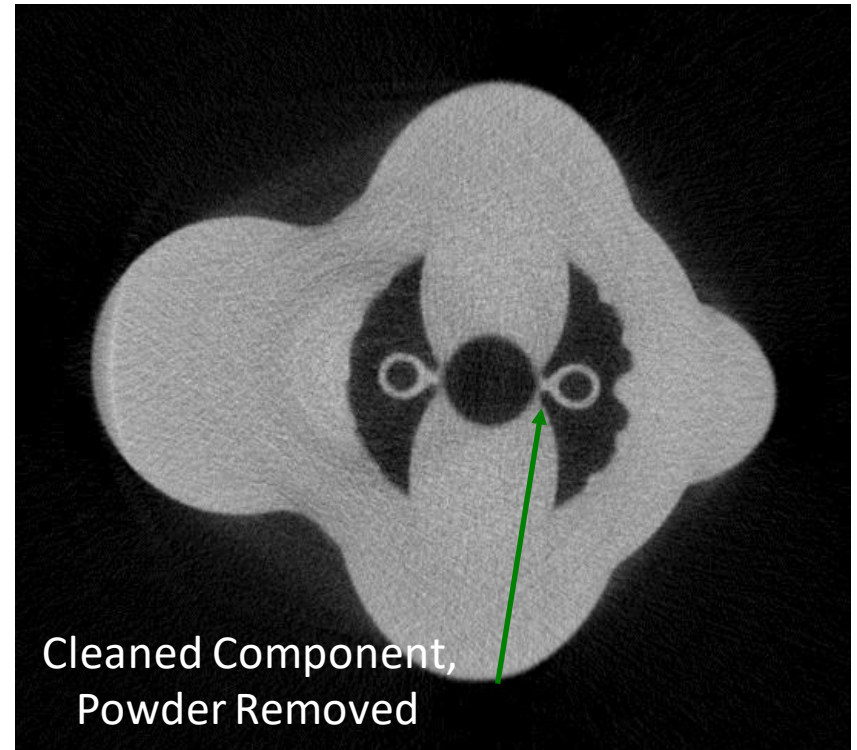
Component # 1 Analysis – Doped VS. Cleaned

Inconel 718 powder was used to dope component #1 by adding powder into the top inlet holes. The part was then shaken for several minutes, then flipped for additional shaking as a means to work the powder into the component.

Powder deposition occurred in different areas as compared to the accrual locations of “As Received” test articles. As a result, the doping process does not appear to represent actual AM powder entrapment mechanisms. It may, however, represent powder dispersal during handling prior to post production processing.

Cleaned Component,
Powder Removed

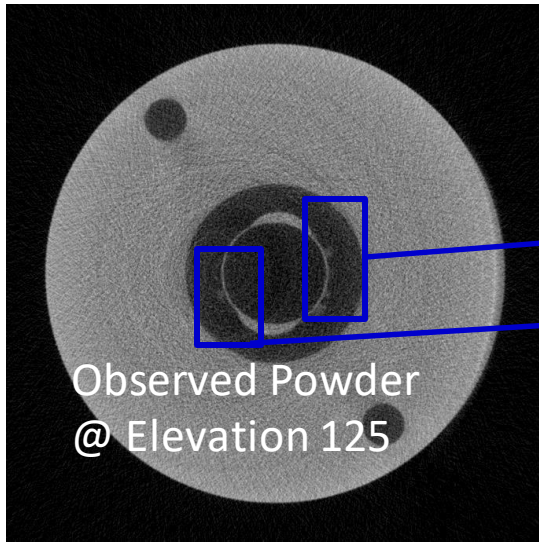
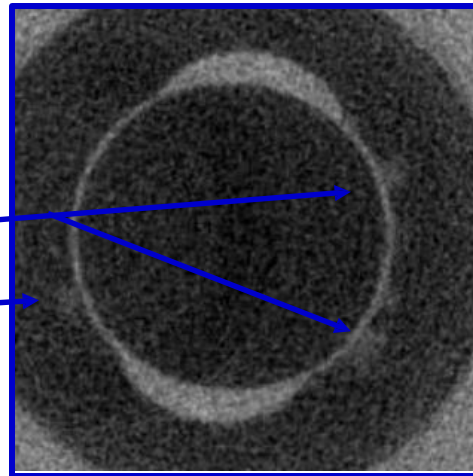
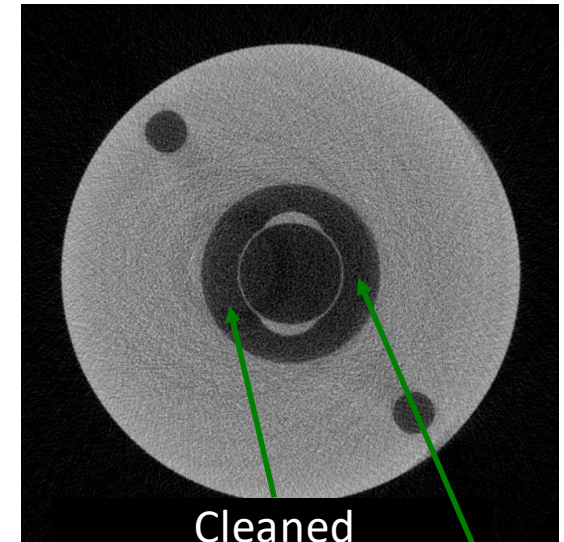
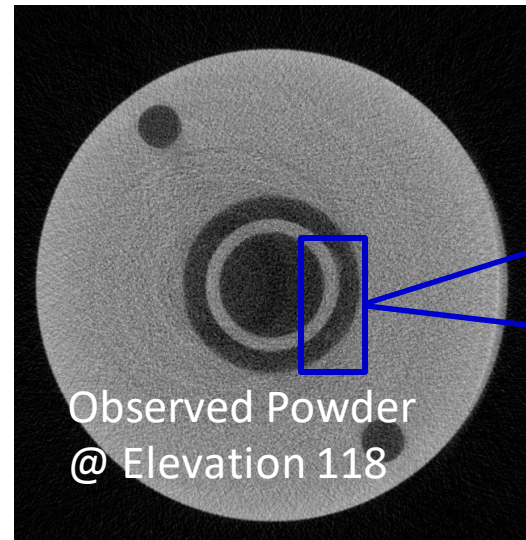
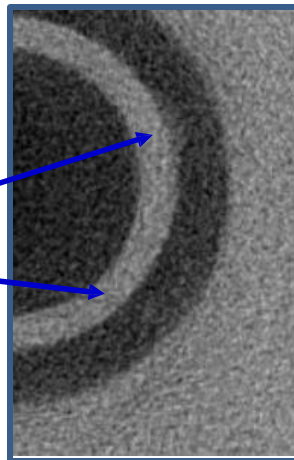
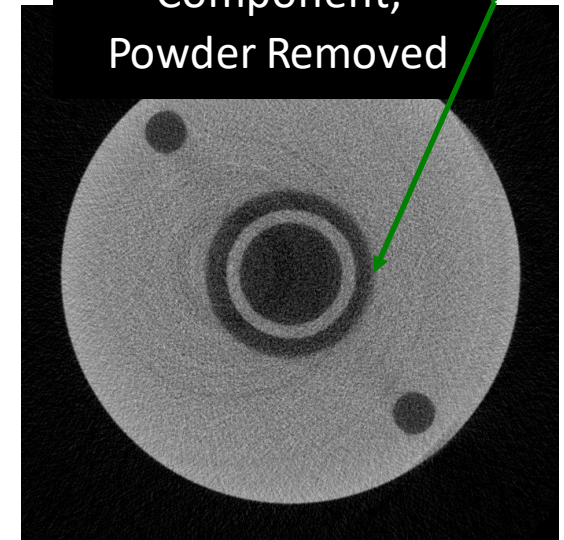
Component # 2 Analysis – As Received VS. Cleaned

Powder was observed in two locations. Cleaning removed powder at one location but not at the interior wall / bottom chamber surface. A wire EDM cut of the affected zone did not show the presence of any mechanical defect, thereby indicating that the artifact in question was most likely powder.
